## **Continuous Verification Monitoring at AC Mitigation Stations**

Jamey Hilleary  
Elecsys Corporation  
846 North Mart-Way Ct.  
Olathe, KS, 66061  
USA

Jerry DeWitt  
Enbridge Energy Partners  
1500 West Main St.  
Griffith, IN 46319  
USA

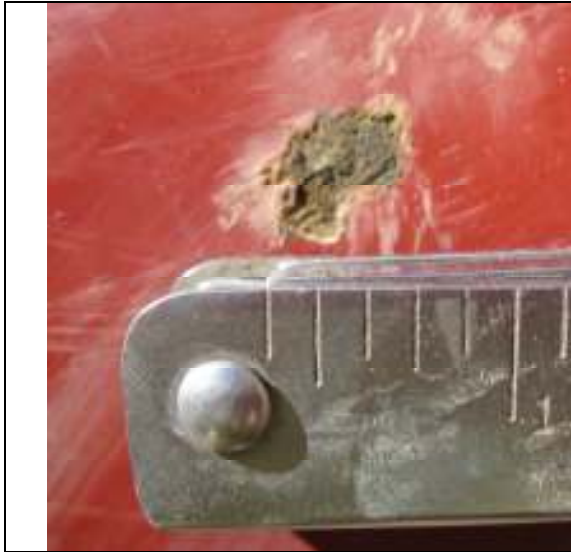
Pipeline construction was completed 3-months prior to the installation of the impressed current cathodic protection systems, and the AC mitigation systems were in the design phase. During this time a coating inspection survey was conducted using an alternating current voltage gradient (ACVG survey). Coating anomaly digs were done at several locations based on the severity of the test results. The first excavation at MP 162 was prioritized and a total of nine coating faults were found, each contained pits ranging in depth from .025 to .085 inches (.635mm – 2.159mm) and from .025 to .500 inches (.635mm – 1.27mm) in diameter (Figures 2 and 3). The corrosion products as well as the coating surrounding the smaller diameter anomalies were burnt in appearance, the larger anomalies did not display this burnt condition but did have deeper pitting. Additional excavations were conducted and pitting was discovered at each location.

**Figure 2: Small coating fault displaying evidence of burnt coating**

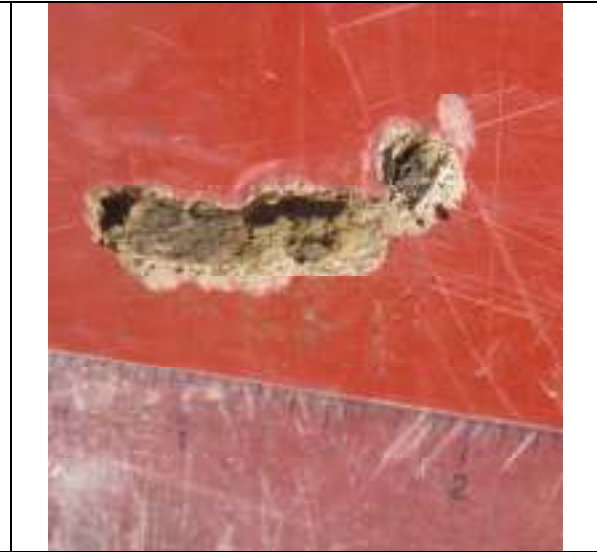
**Figure 3: Larger diameter fault showing deeper pitting.**

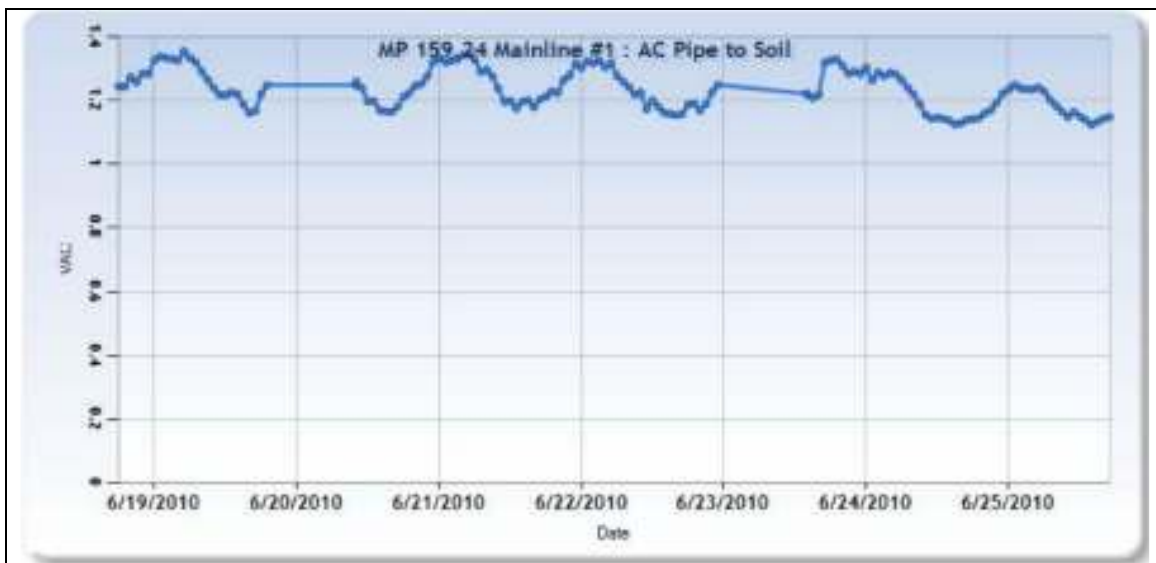
The first ten AC mitigation facilities were installed on this pipeline between milepost 146.34 and milepost 166.38 in May of 2010. Monitoring equipment was installed in June of 2010 at the mitigation facility locations at milepost 159.24 and milepost 163.53. These two locations registered the highest induced AC voltages on the pipeline. Measurements taken prior to the installation of the mitigation systems showed induced AC voltage  $>64\text{VAC}$  at milepost 163.53 and  $>25\text{VAC}$  at milepost 159.24. AC current measurements were  $>140\text{A/m}^2$  at milepost 163.53 and  $>80\text{A/m}^2$  at milepost 159.24. The graphs below, displaying data measurements at the test locations, are generated from the monitor system web interface. The data in the graphs confirmed reduction of induced AC voltage to acceptable levels at these two locations following the installation of the first ten systems (Figures 6 and 7).

**Figure 6: Mitigated induced AC voltage on mainline #1 at milepost 159.24**

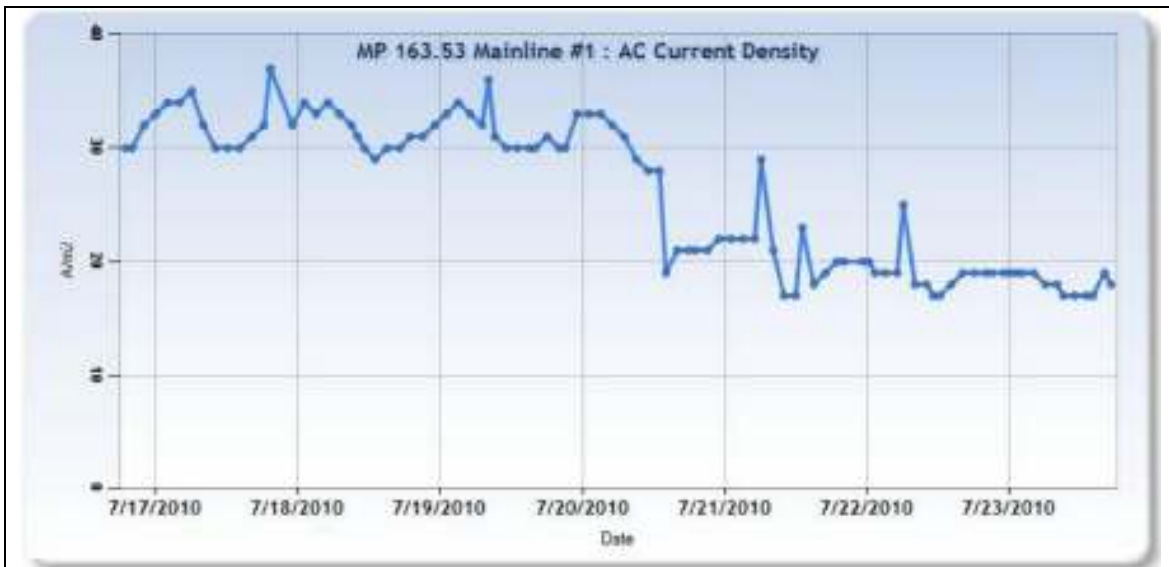
**Figure 11: Mitigated AC current on mainline #1 at milepost 163.53. Installation of additional mitigation devices occurred on 7/20/2010.**

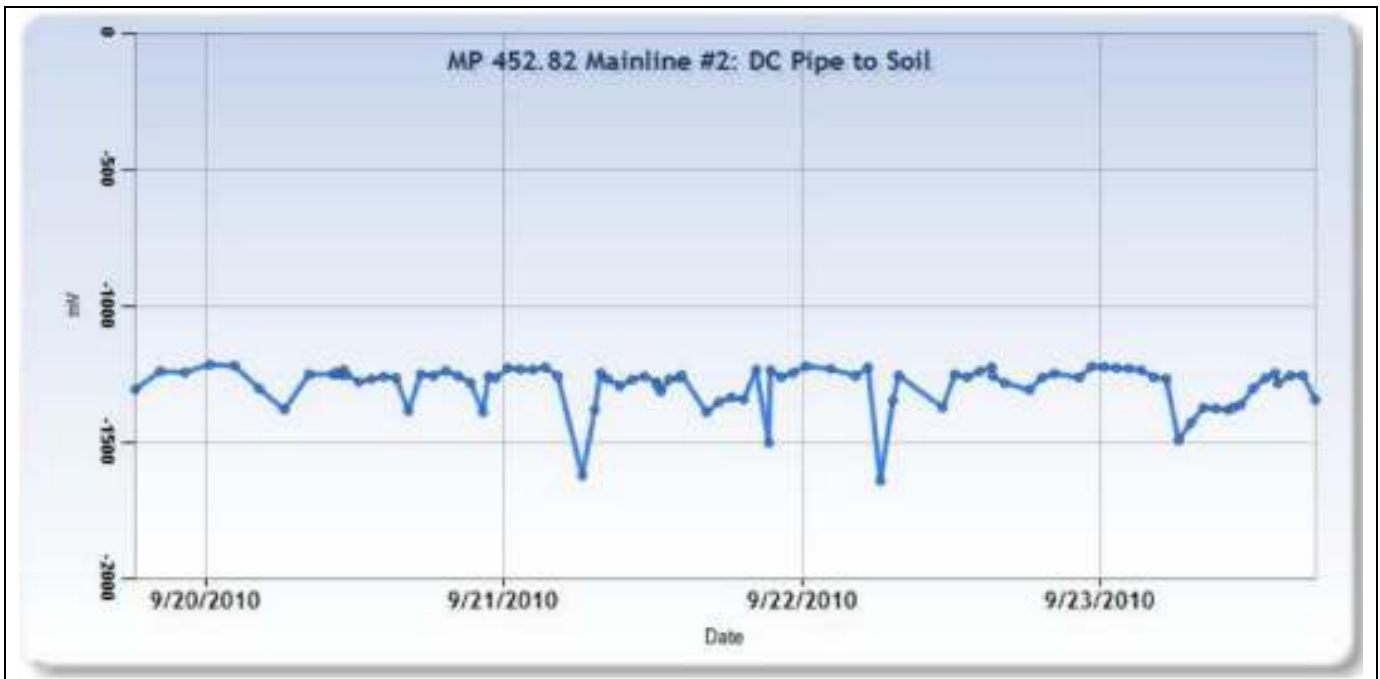
When the system was disconnected, the induced AC voltage and the AC corrosion current levels both went into the alarm range and notifications of the alarm readings were sent to the technicians administering the pipeline. The mitigation system was reconnected on the afternoon of September 22, 2010, at which time all values returned to the normal, mitigated range. The graphs in Figures 12, 13, and 14, display induced AC voltage, AC corrosion current, and DC pipe to soil values recorded during this test. The induced AC voltage and the AC corrosion current fluctuated cyclically throughout the system failure, reflecting cyclical changes in the load levels on the overhead lines corresponding with the time of day. Peak loads on the electric power transmission system in the afternoon and early evening hours corresponded with increased induced voltage measurements on the pipeline, and lower demand loads over night and in the early morning hours corresponded with lower induced voltage levels.

The voltage measurement in particular is significant, as many of the values recorded during this event were below the safe touch limit, but were not indicative of the voltage level occurring throughout the system failure test. In addition, the AC corrosion current levels registered at the low points of induced AC voltage were significantly above the <20A/m<sup>2</sup> acceptable value. If verification of the mitigation

**Figure 14: DC pipe to soil potential measurements associated with disconnection of the AC mitigation system at Mainline #2, milepost 452.82**
