## **Continuous Verification Monitoring at AC Mitigation Stations**

Jamey Hilleary  
Elecsys Corporation  
846 North Mart-Way Ct.  
Olathe, KS, 66061  
USA

Jerry DeWitt  
Enbridge Energy Partners  
1500 West Main St.  
Griffith, IN 46319  
USA

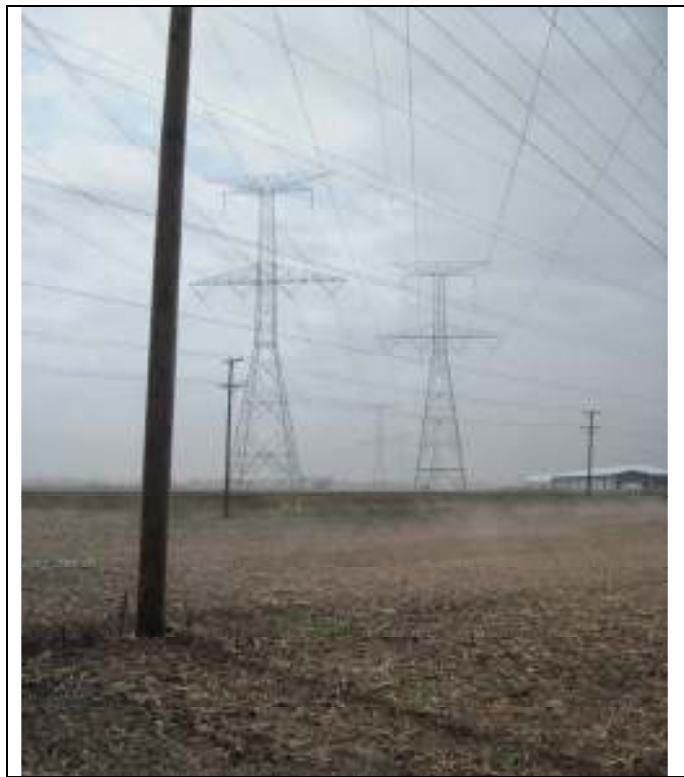
**Figure 1: AC transmission lines on the pipeline right of way.**

The field study was done in two phases on separate pipelines. The sites selected for the first phase of the study were on a newly constructed fusion bond coated, 20-inch (50.8cm) diameter pipeline located in Northern Illinois. The pipeline is collocated with overhead high voltage transmission lines in two separate locations. The first collocation runs approximately four miles from MP 146 to MP 150, second collocation from MP 155 to MP 167. The pipeline is parallel with one double delta circuit configuration at 345kV. The overhead circuits induce voltages in excess of the NACE safety criterion of 15 volts during steady state operation fluctuating between 40 and 77 volts (Figure 1). The test sites were located at MP 159 and MP 163 where the highest AC values were measured.

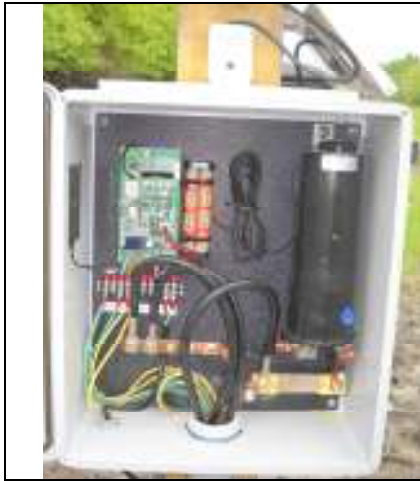
**Figure 4: AC mitigation facility with monitor system.**

The monitoring systems were equipped to measure induced AC voltage potential, AC corrosion current, DC pipe to soil potential, DC pipe to soil off potential, and native potential using a dual coupon test station design. All values were read at one minute intervals and stored on 2GB SD memory cards in the monitor devices. The monitor systems were equipped with GSM cellular communication capability and readings were transmitted to the web interface every three hours. Stored data from the devices could be retrieved by downloading the stored readings from the SD cards directly into a computer or by retrieving the logged data through the web interface. The monitors were set to transmit immediate notification of any alarm level readings. The alarm levels for induced AC voltage were set at 15 volts and the alarms for AC current density were set at  $20\text{A}/\text{m}^2$  as measured at  $1\text{cm}^2$  surface area coupon holidays. The monitor equipment and mitigation systems were installed in integrated enclosures at dual coupon test station locations on the pipeline (Figures 4 and 5). These mitigation systems reduced the steady state pipe voltages to less than 10 volts for normal peak loading of the transmission line circuits.

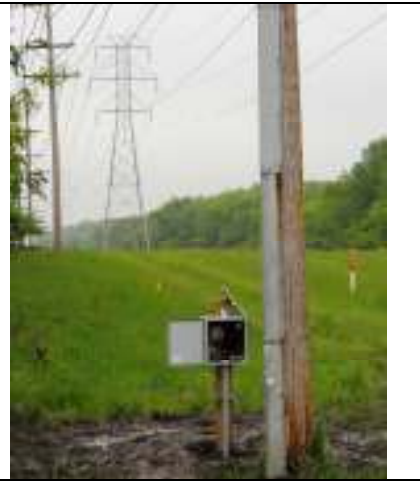
**Figure 5: Mitigation facility installed on right of way.**

The first ten AC mitigation facilities were installed on this pipeline between milepost 146.34 and milepost 166.38 in May of 2010. Monitoring equipment was installed in June of 2010 at the mitigation facility locations at milepost 159.24 and milepost 163.53. These two locations registered the highest induced AC voltages on the pipeline. Measurements taken prior to the installation of the mitigation systems showed induced AC voltage  $>64\text{VAC}$  at milepost 163.53 and  $>25\text{VAC}$  at milepost 159.24. AC current measurements were  $>140\text{A/m}^2$  at milepost 163.53 and  $>80\text{A/m}^2$  at milepost 159.24. The graphs below, displaying data measurements at the test locations, are generated from the monitor system web interface. The data in the graphs confirmed reduction of induced AC voltage to acceptable levels at these two locations following the installation of the first ten systems (Figures 6 and 7).
