Watchdog P2S-AC
Remote Monitor

Proactive AC Mitigation Monitoring Increases Safety and Pipeline Integrity

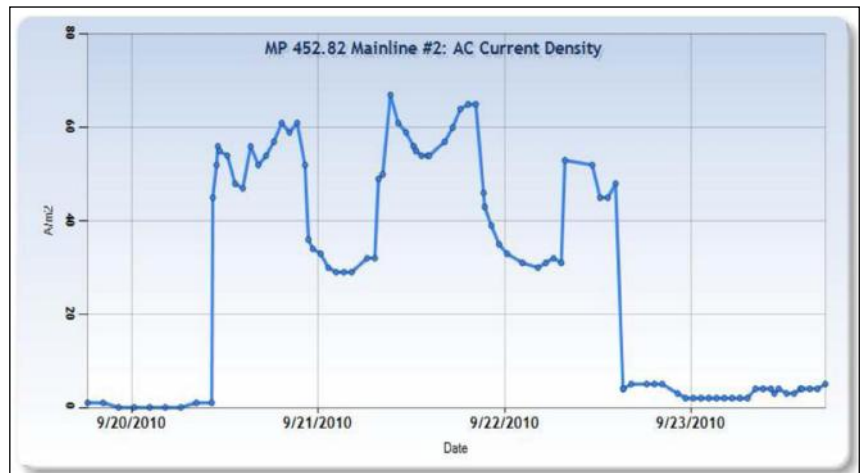
Figure 1. AC corrosion current level changes associated with disconnection of the AC mitigation system

To test a mitigation failure, the system was disconnected at one site location for a two day period. The graphs in Figures 1 and 2 are screen shots from the Pipeline Watchdog one-click graphing tool. These graphs clearly show the changes in induced voltage and current

density resulting from this failure simulation. Of particular note is the daily fluctuation seen in the readings.

The unmitigated voltage readings shown in Figure 2 were often below the safe touch standard of 15 volts during the test period, yet were also frequently in the danger zone. Periodic measurements by field technicians, depending on the time of day made, may fail to detect frequent unsafe conditions. Additionally, AC current densities displayed in Figure 1 remained above the desired maximum level of 20A/m² even when the induced voltage level was in the safe range.

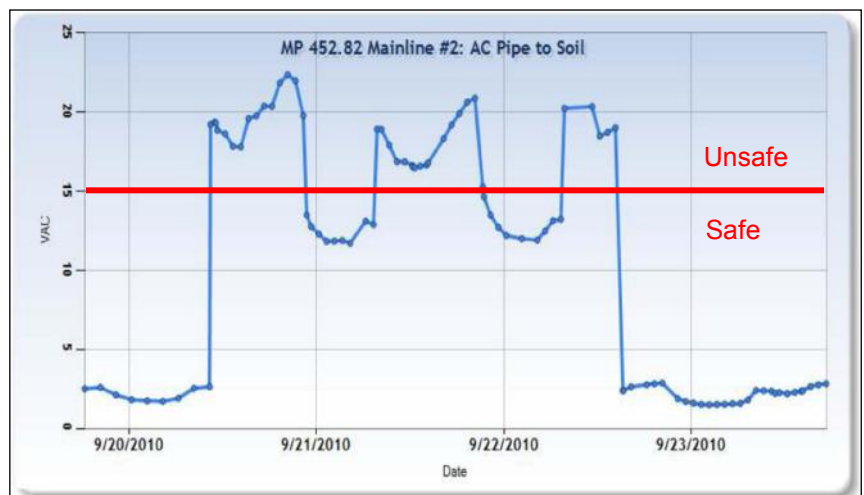
Figure 2. Induced AC voltage level changes associated with disconnection of the AC mitigation system
